## RECREATION AND WELFARE COMMITTEE

**COMMUNITY FACILITIES – MAINTENANCE WORKS**

**STRUCTURAL APPRAISAL**  
**DAFEN COMMUNITY HALL,**  
**LLANELLI,**  
**CARMARTHENSHIRE**  
**SA14 8LW**

**RCA REF: 19778**

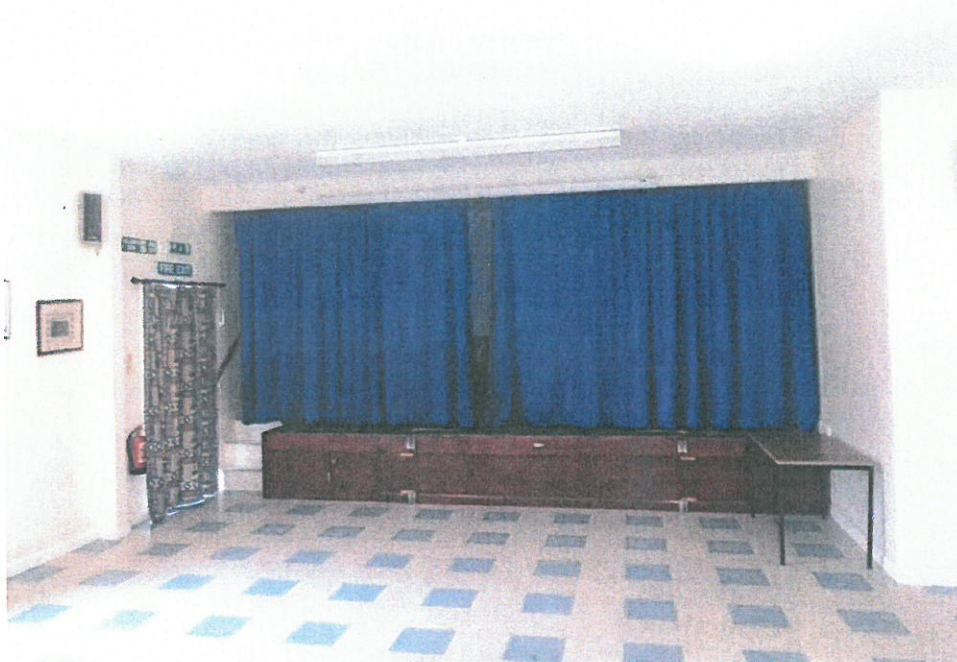
Photograph 1 – General view of extension area

The cracking appears to be located at the junction where the extension meets the existing building. Refer to Photograph 1.

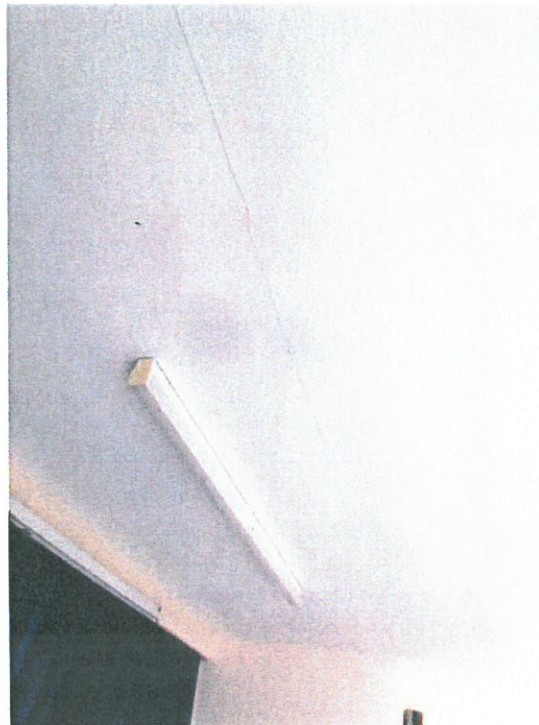
Photograph 2 – Cracking to ceiling

The cracking observed to the hall area, which ranges from hairline to approximately 2mm wide, appears to be all along the ceiling finishes, down both adjacent walls and across the floor finishes. Refer to Photographs 2, 3, 4 and 5.

The cracking across the ceiling is in line with the cracking down the adjacent walls, which are in line with the cracking the the floor tiles. The cracking across the vinyl (possibly asbestos containing) floor tiles appear to have cracked through some tiles and distorted others. Refer to Photograph 6. The artex (possibly asbestos containing) ceiling finishes have spalled in some locations. Refer to Photograph 7. We suggest that professional advice is sought out regarding the risk of asbestos contamination due to the cracked floor tiles and spalling ceiling finishes. The overall pattern of cracking observed suggests that the extension has moved away from the main building.

Settlement of the extension may be the cause of the cracking observed, however based on the pattern of cracking which appears to be of equal magnitude to both ceiling and floor level it is not likely to be the only cause. The cracking may also be caused by thermal expansion and the fact that the walls and concrete slab of the extension may not be sufficiently tied/fixed to the existing building. The lack of buttressing compared to the number of openings may also be a contributing factor. An additional contributing factor could be defective drainage.

In order to reduce the risk of the cracking from occurring further we suggest the installation of three number timber noggins to each side of the junction of the extension, with structural restraint straps nailed across the top at 1.2m centres at both ceiling and roof level. Additionally, in order to reduce the risk of further cracking of the walls we recommend that stitching be undertaken using stainless steel Helifix type bar systems (<http://www.helifix.co.uk/applications/repairing-cracks-near-corners-and-openings/>) – embedded in the wall and extended around the internal corner.

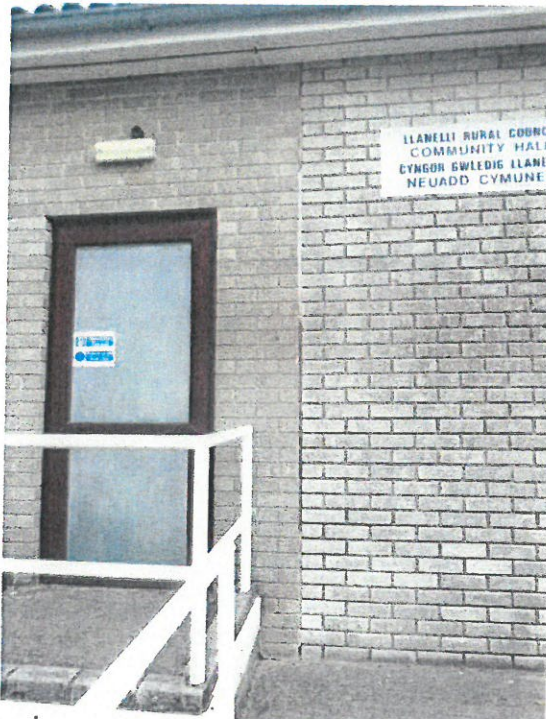
Photograph 8 – External expansion joint to front wall

Externally the junction of the extension and the existing building has flexible expansion joint sealant present. No cracking would show at these locations due to the flexible sealant. Refer to Photographs 8 and 9.
