PWYLLGOR LLES A HAMDDEN

AGENDA

6. Adroddiadau Arolygu Meysydd Chwarae – derbyn adroddiadau arolygu meysydd chwarae ar gyfer cyfleusterau chwarae'r cyngor gan ReZabond Surface & Play Limited a chytuno ar ymateb y cyngor.

ReZabond
Surface & Play Ltd

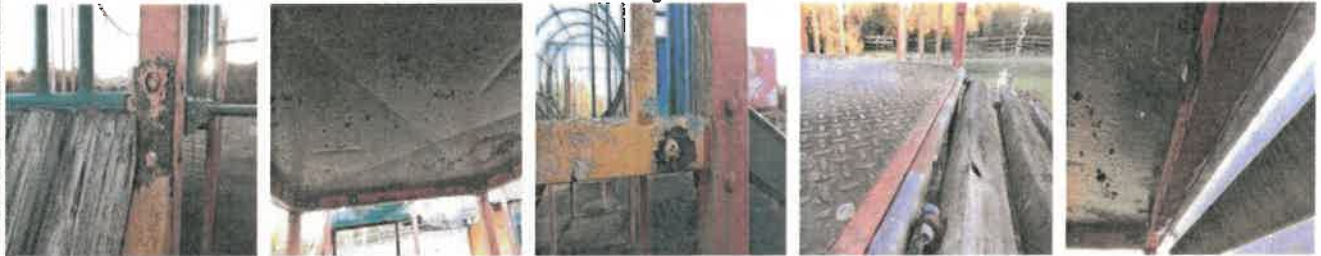
Finding Photos

Asset	Multiplay Unit	 
Finding Group	Maintenance	
Finding Title	Metal - Paint-work - Not in Good Condition	
Standard Description	Metal paint-work condition	
Finding Notes		
Risk Level	Low	Asset Photo

Metal - Paint-work - Not in Good Condition - Task

Task Title	De-rust and coat with paint meeting EN 1176 - 4.1.1 [1998]
------------	--
